2005 Report Card
The Ecological Health of the
San Miguel River Watershed

Produced by
The Nature Conservancy and the
San Miguel Watershed Coalition

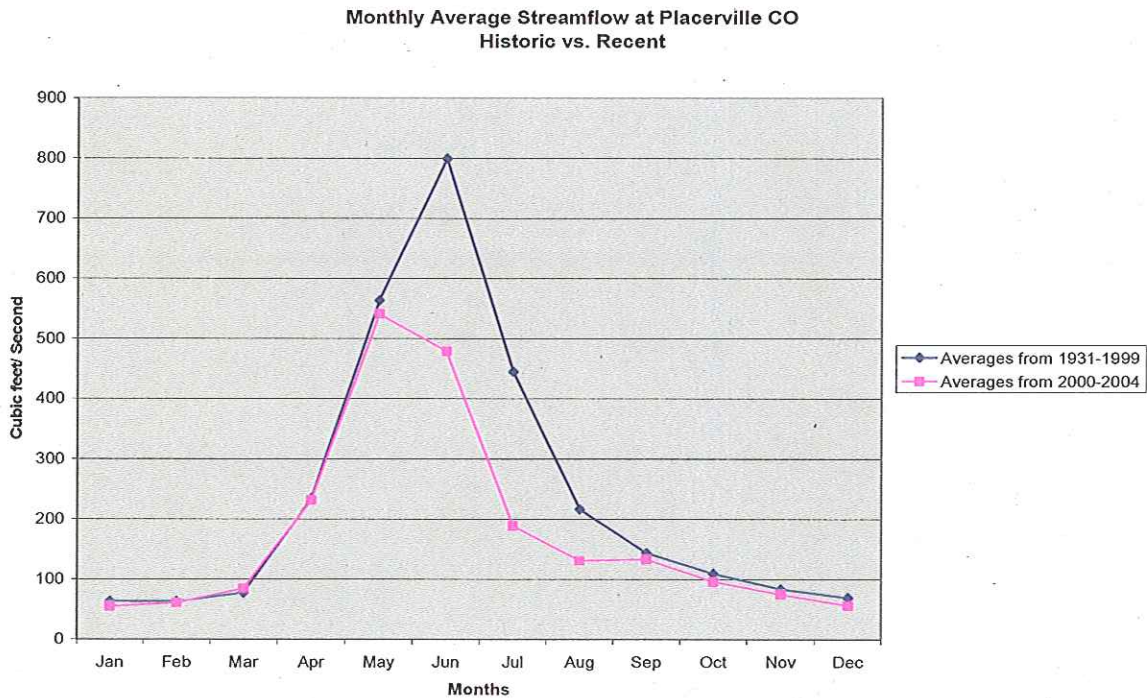
Average Flows

This graph shows a 40% reduction in recent flow volume for the month of June, a 58% reduction in July, and a 40% reduction in August, as compared to the long term averages at this site since data was collected consistently. Minimal reductions in volume are also shown for September through December. This reduced flow volume in the river can be mostly attributed to drought that occurred over the last five years, especially in 2002.

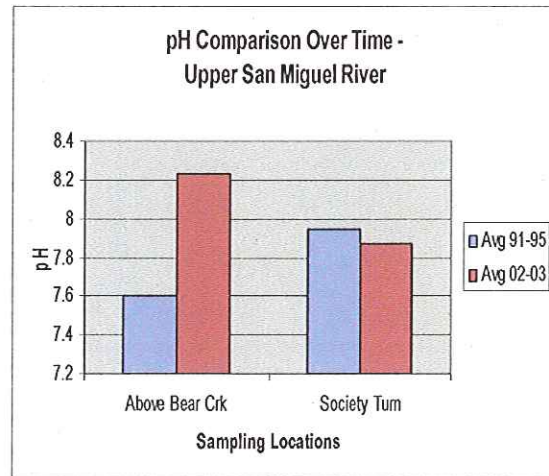
Both zinc and manganese levels have significantly declined at this site over time, which is good for aquatic life. The pH level of the river water has decreased significantly, or become less acidic, over time as well. These are very positive results of the Idarado mining clean-up!

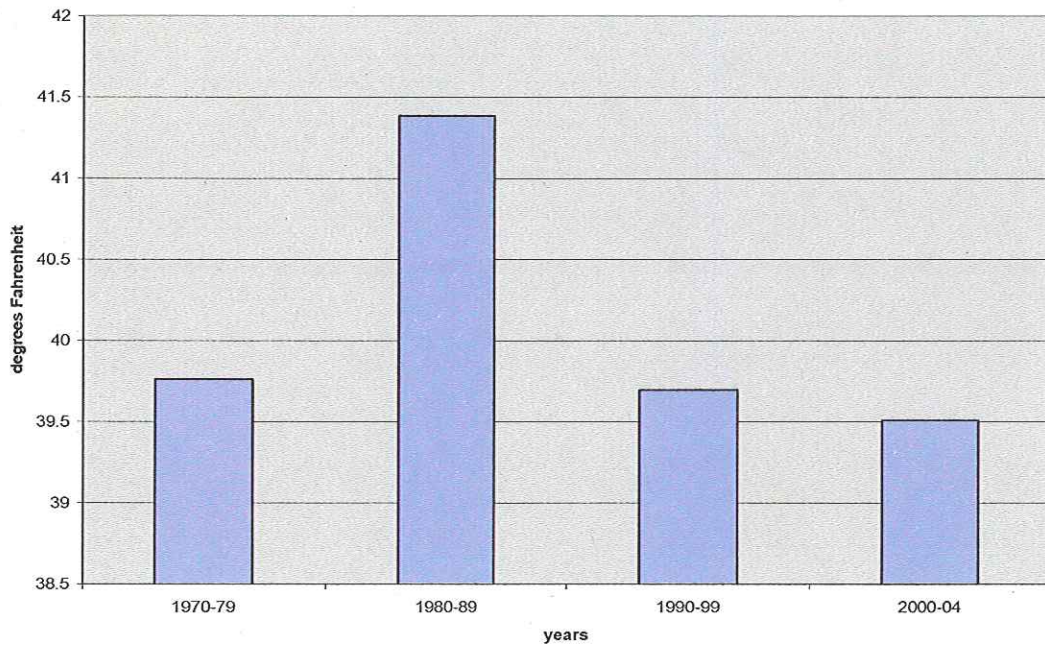
Average annual temperatures Telluride

From this data, average temperatures in Telluride have actually decreased, with 1980-1989 the warmest decade on record. This should be re-evaluated as more data for this decade is available.

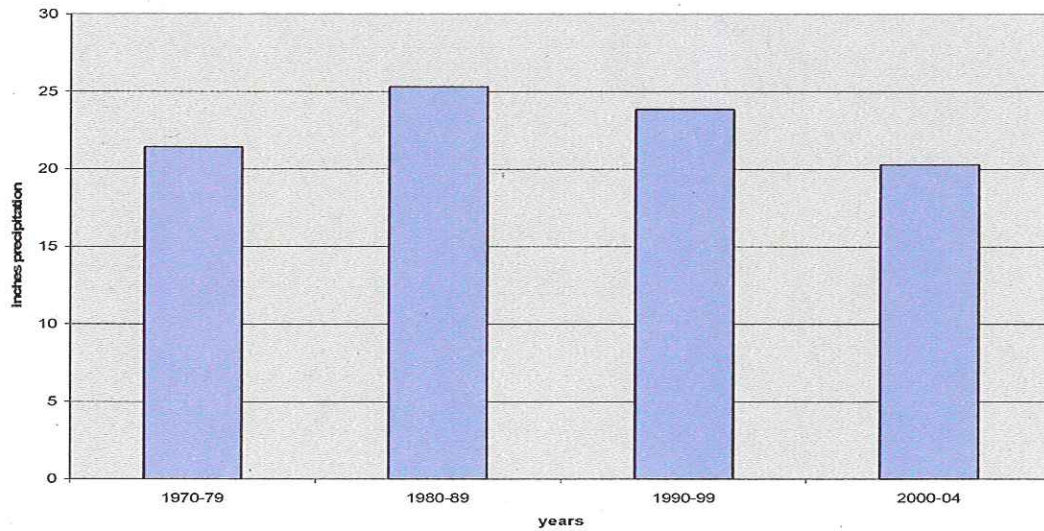
Average annual precipitation Telluride

Average precipitation in Telluride is lower for the recent years than the previous three decades. This trend is of serious concern. The results available for this decade will be watched closely!

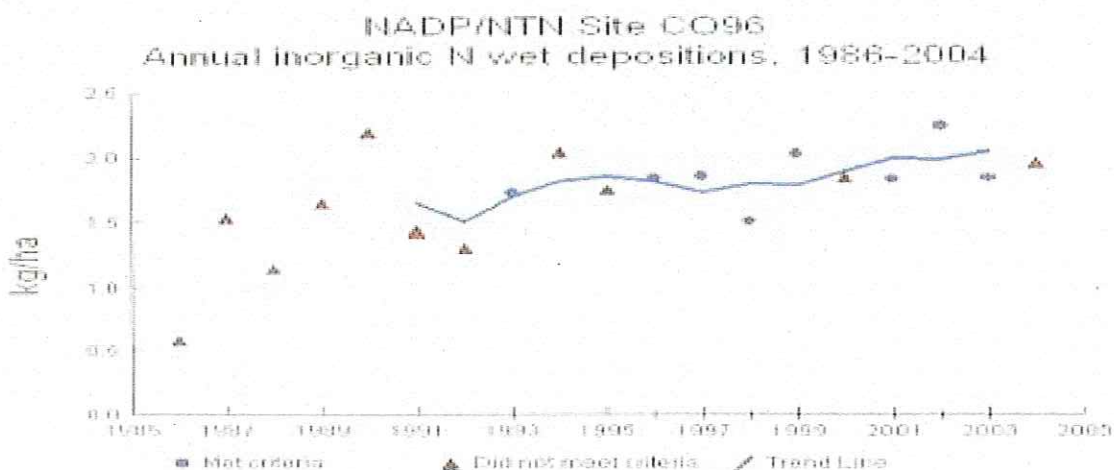
National Atmospheric Deposition Program, Molas Pass site

*There is no National Atmospheric Deposition Program site within the San Miguel River watershed, so the closest data available from the Molas Pass and Wolf Creek Pass sites is used to extrapolate trends that exist within this watershed. According to the National Park Service web site, pre-industrial or natural levels of nitrogen deposition are estimated to be about 20 times lower than current deposition, at around 0.2 kg/ha/yr.

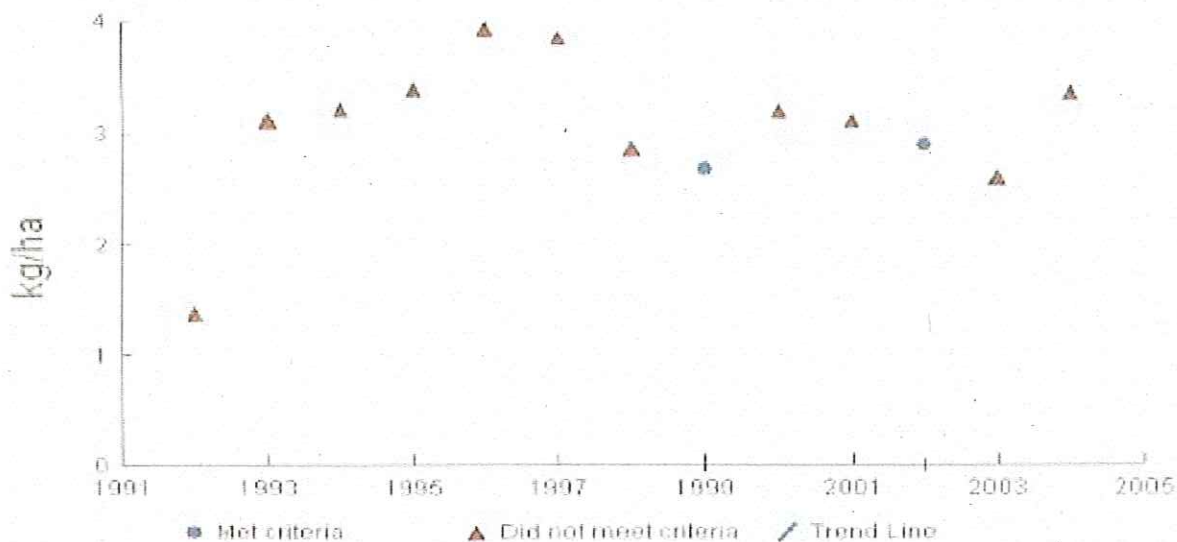
National Atmospheric Deposition Program, Wolf Creek Pass site

NADP/NTN Site CO91
Annual inorganic N wet depositions, 1992-2004

* Triangle symbol indicates the data point did not meet criteria. This is due to the mountain setting of these sites and proportion of precipitation which is snowfall. Data value is considered to be valid.

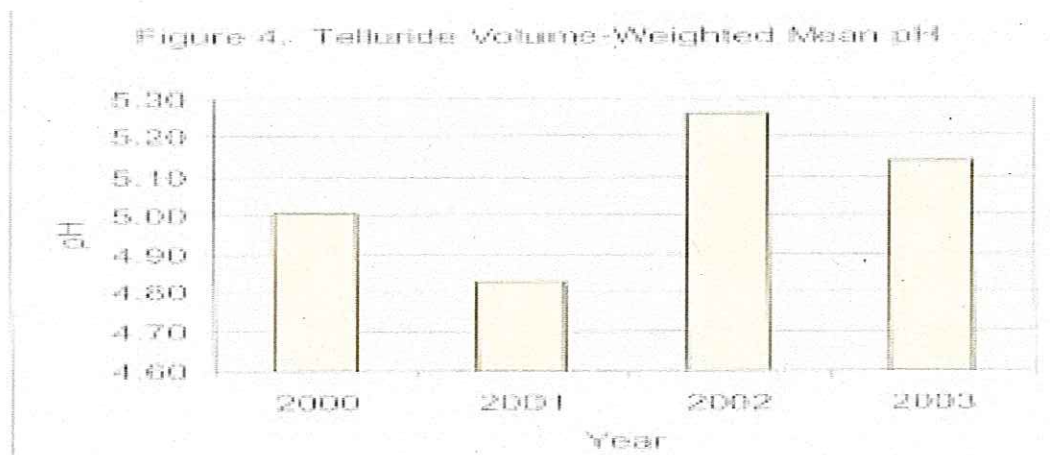
Figure 4. VWM pH values of wetfall to the Telluride AIRMoN-type site for the summers of 2000, 2001, 2002, and 2003.

*According to the Environmental Protection Agency web page on acid rain, the most acidic rain falling in the U.S. has a pH of about 4.3. Pure water has a pH of 7. Normal rain, because it has absorbed carbon dioxide, has a pH of about 5.5.

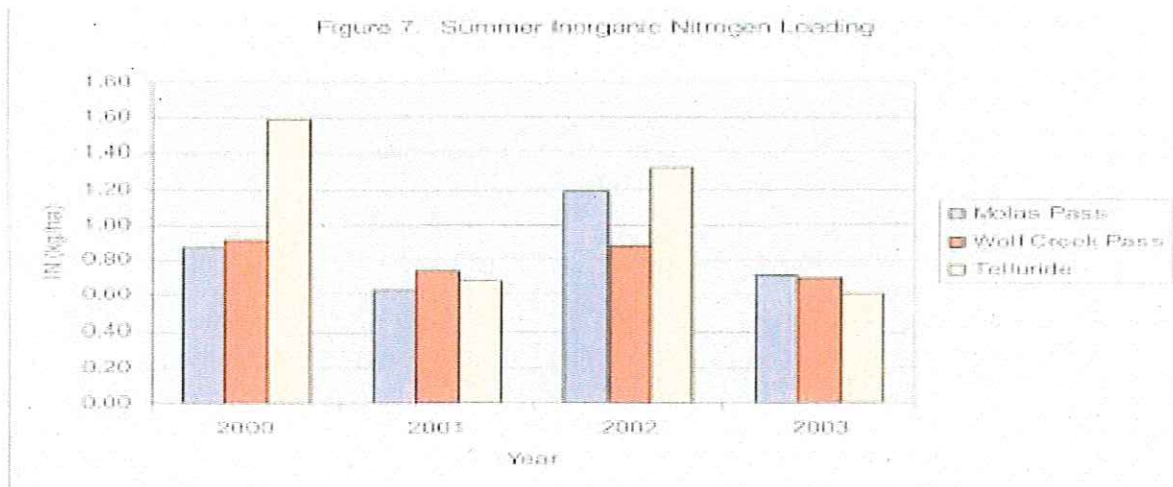
Figure 7. Inorganic nitrogen deposition in wetfall to the Telluride AIRMoN-type site and comparison to nearby NADP sites at Molas Pass and Wolf Creek Pass for the period of study during the summers of 2000, 2001, 2002, and 2003.

* A different sampling protocol was used for the Telluride site in 2000 which may have contributed to the elevated nitrogen levels shown on the graph for the Telluride site relative to the Wolf Creek Pass and Molas Pass sites.
