SAN MIGUEL WATERSHED REPORT CARD UPDATE 2006

WATER

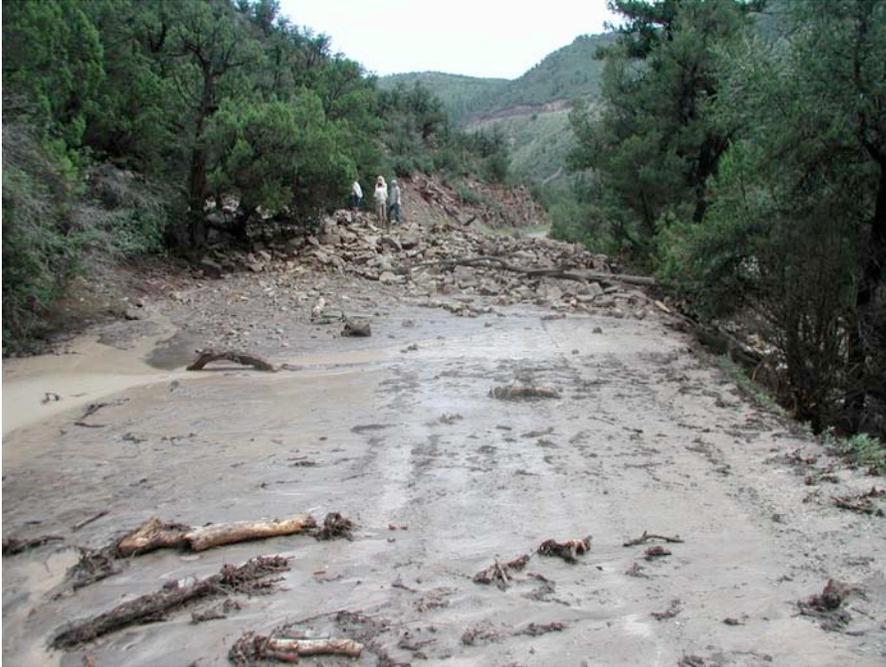
Figure 1 Sanborn Park Road after Flood on August 2, 2006

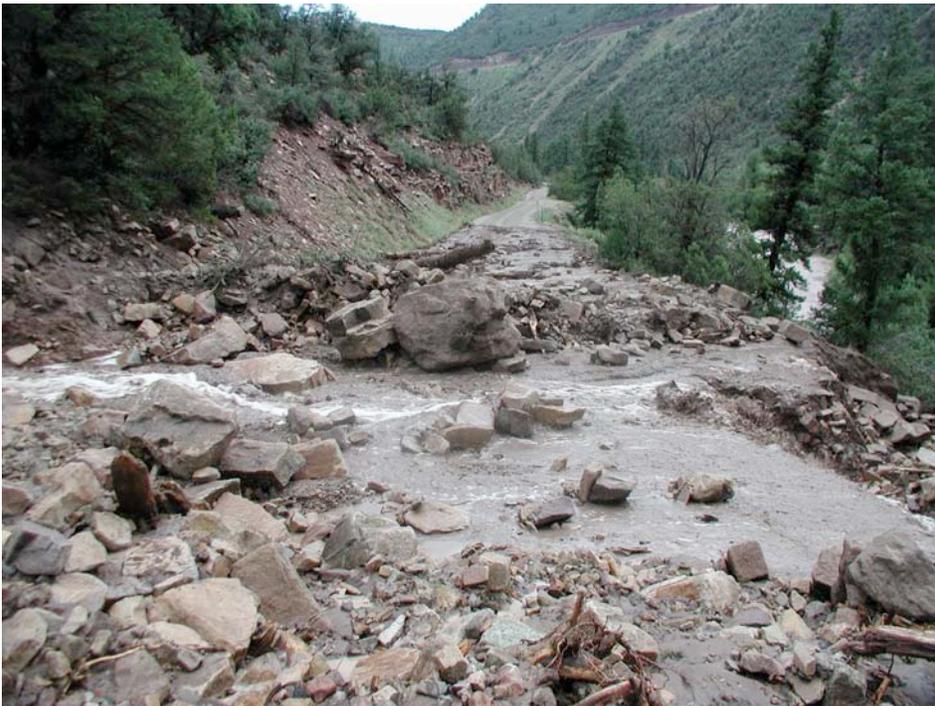
Figure 2 Flood Debris on Sanborn Park Road, August 2, 2006
